MEMORANDUM REPORT ARBRL-MR-03356

HASTINGS IGLOO HAZARDS TESTS FOR
SMALL EXPLOSIVE CHARGES

May 1984

US ARMY ARMAMENT RESEARCH AND DEVELOPMENT CENTER
BALLISTIC RESEARCH LABORATORY
ABERDEEN PROVING GROUND, MARYLAND

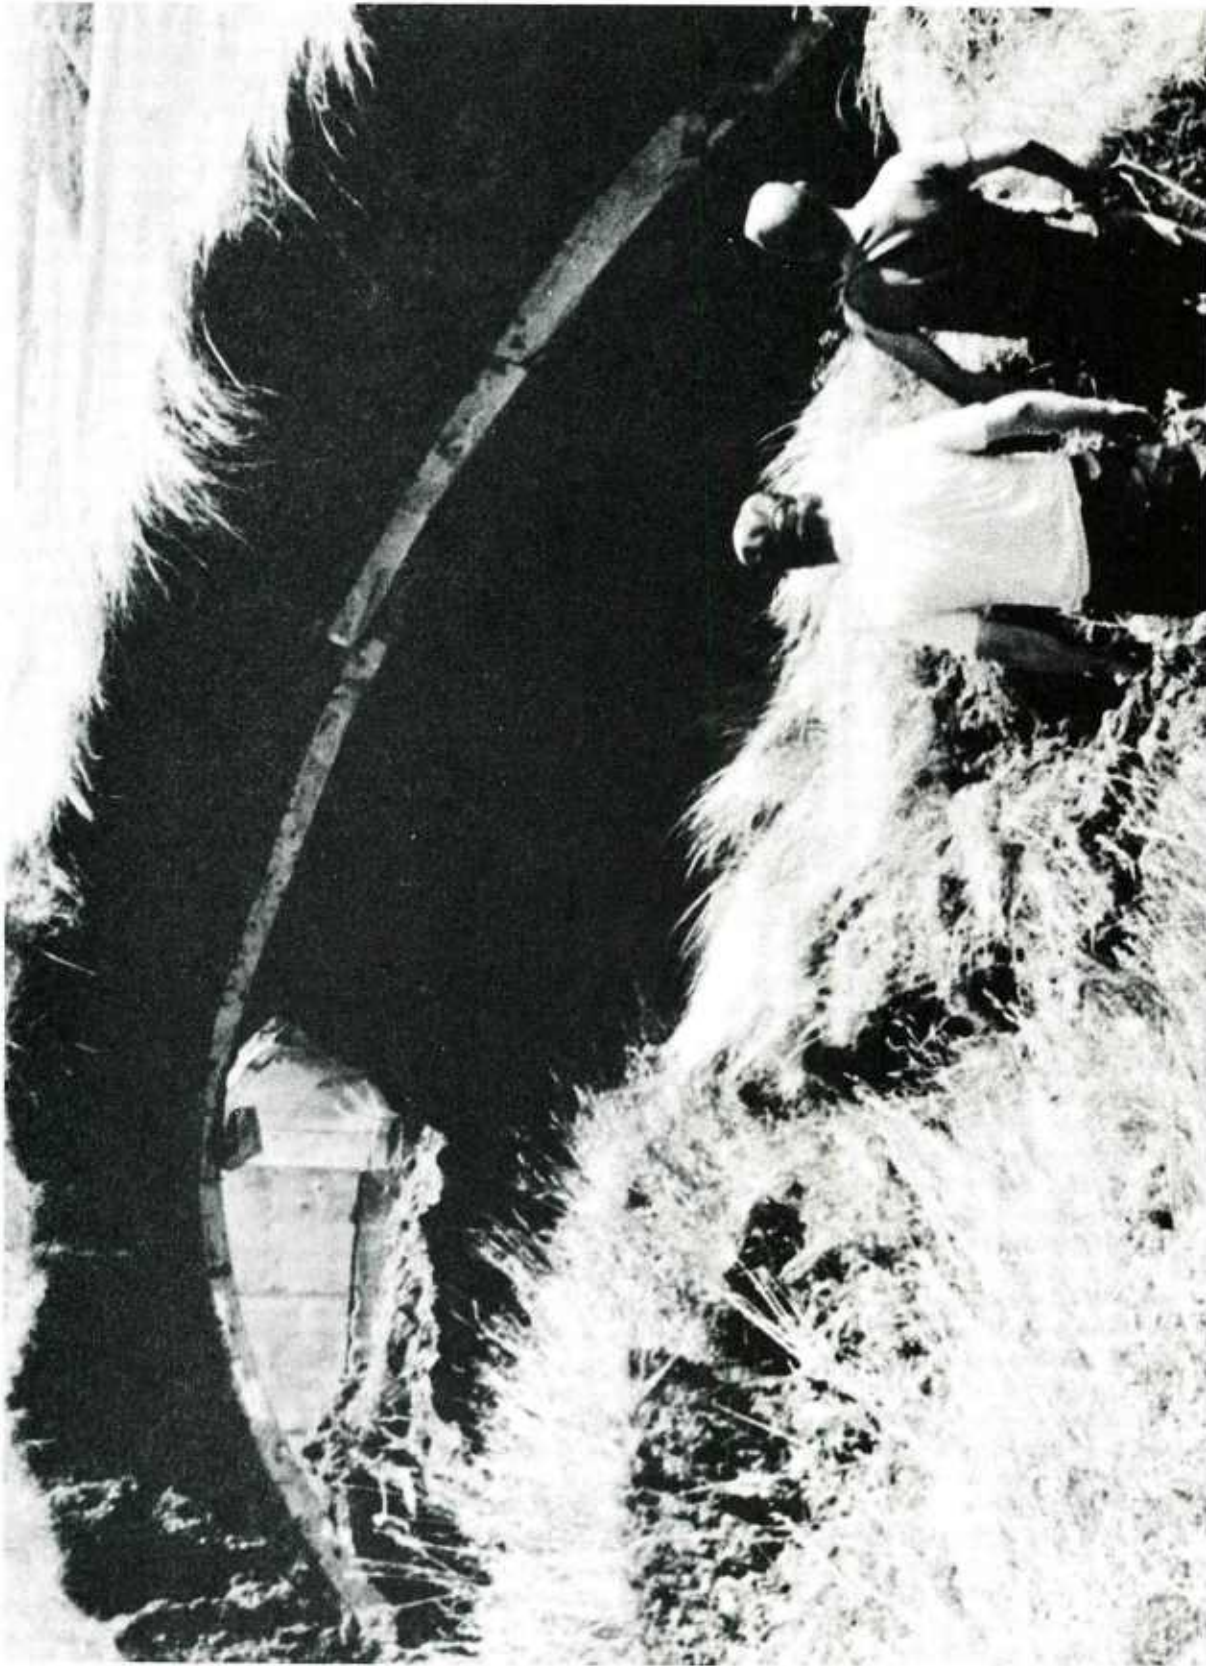
Figure 7. Test Results - Test No. 1, 18 Kg TNT Charge
Positioned Inside Magazine 4 Metres from Headwall

Test No.	Charge Wgt.	Charge Position	Remarks
1	18 Kg (40 lb)	4 m (13 ft) from headwall	Headwall failed. Approximately 50% of the arch crest and 35% of the sidewalls in the front and rear of the igloo destroyed. All debris from arch crest and sidewall recovered on the floor of the igloo. Large center section of the igloo remained standing. Some debris from headwall scattered along entrance roadway after bouncing off blast shield. One large piece (5.4 Kg) of concrete from headwall cleared blast shield and recovered 40 metres in front of the headwall. Parts of terra cotta vent stack scattered up to 10 metres from the rear of the magazine. The wood core and metal sheathed doors were destroyed and recovered between headwall and blast shield. See Figure 7.
2	11 Kg (24 lb)	4 m (13 ft) from headwall	Headwall failed. Arch crest cracked and displaced. Forward section of left sidewall failed. See Figure 8. A total of nine concrete fragments weighed in excess of 4 Kg. The remainder of the fragments weighed between 0.5 Kg and 2.0 Kg. A large piece of the door (9Kg) recovered 30 metres to the right and 7 metres behind the headwall.

The inconsistency observed between the results of Tests 1, 2, and 7, where a 7.3 Kg charge produced more severe structural damage than either an 11 Kg or 18 Kg charge, can only be explained in terms of unobservable differences in the condition of the magazines before testing.

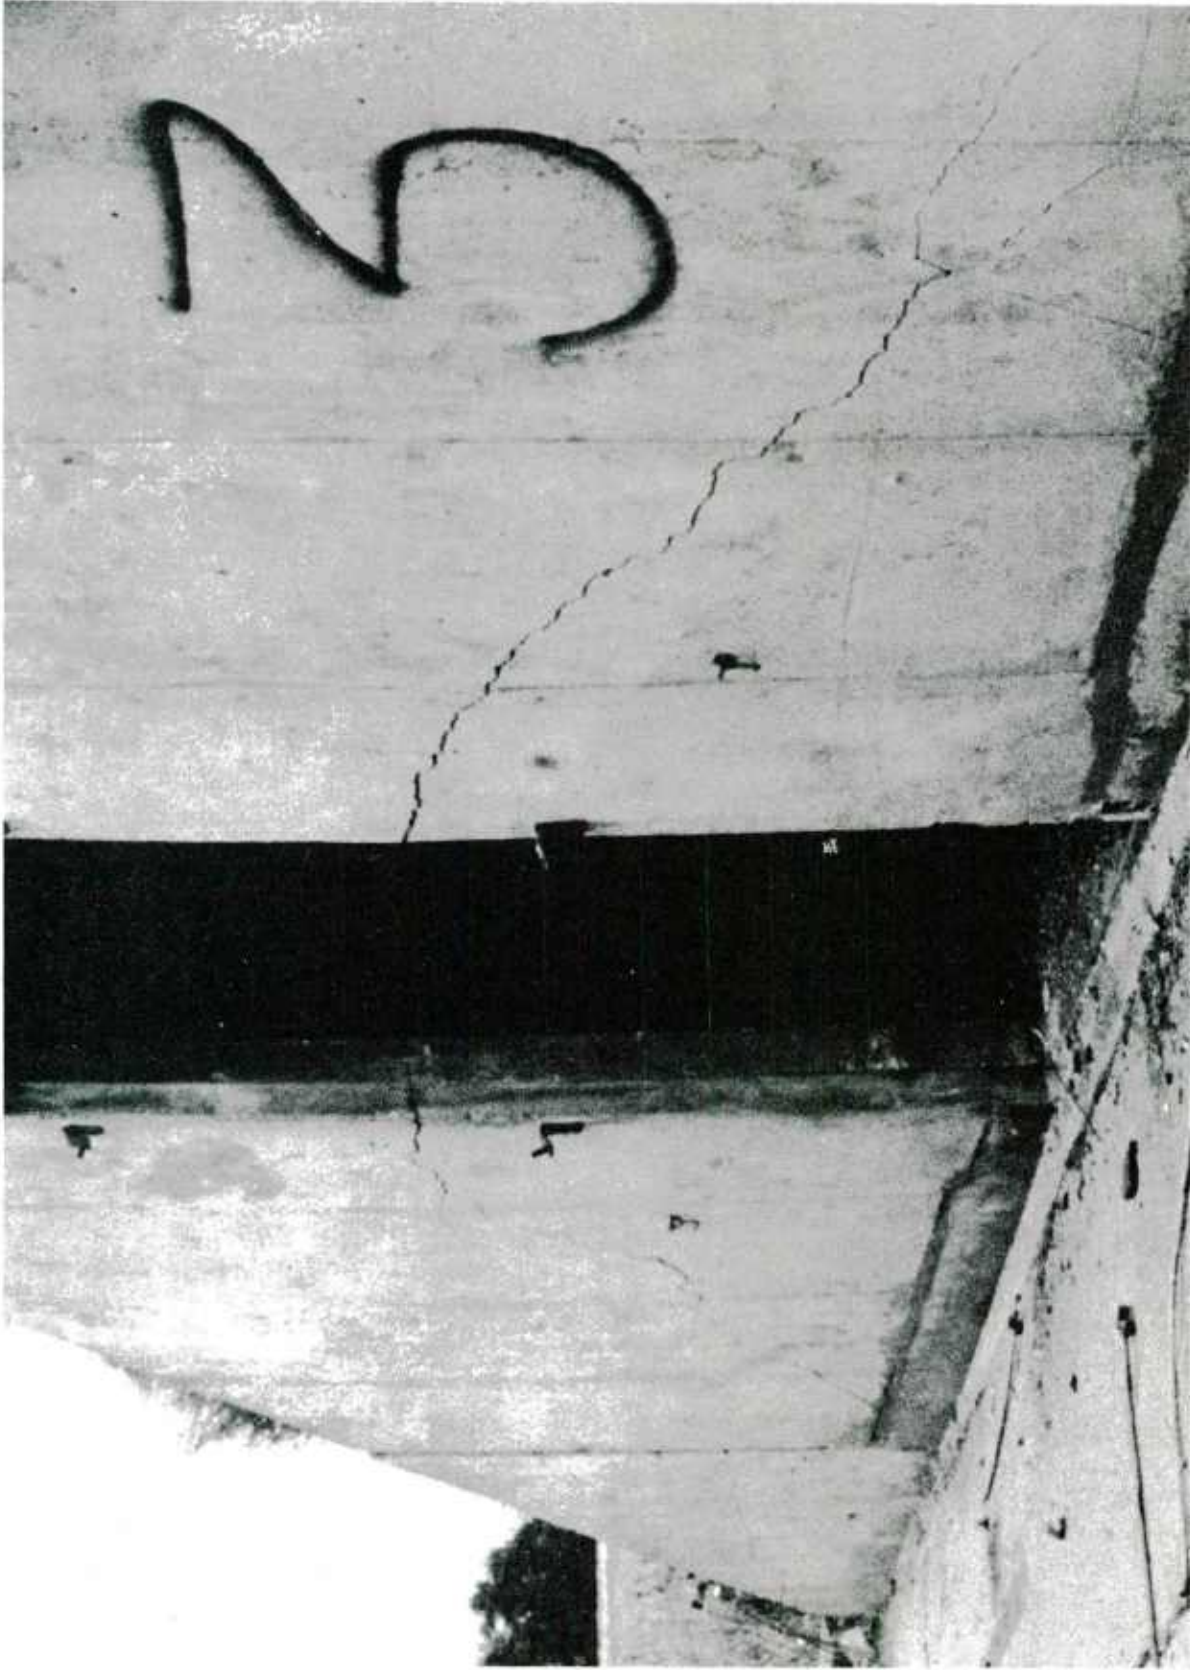
Figure 9. Test Results - Test No. 3, 5.4 Kg TNT Charge
Positioned Inside Magazine 4 Metres from Headwall

3	5.4 Kg (12 lb)	4 m (13 ft) from headwall	There was a large crack in the face of the headwall. The headwall was still in one piece and standing in place. See Figure 9. The right side door recovered 15 metres from the center of the headwall on the right side. The left side door recovered 30 metres from the center of the headwall on the left side.

While the results of Tests 3, 4, and 5 (5.4 Kg charge positioned 4 metres from the headwall) are observably different, the differences in terms of structural response are not significant and could be explained in terms of variations in the structural integrity of these 40-year old magazines.

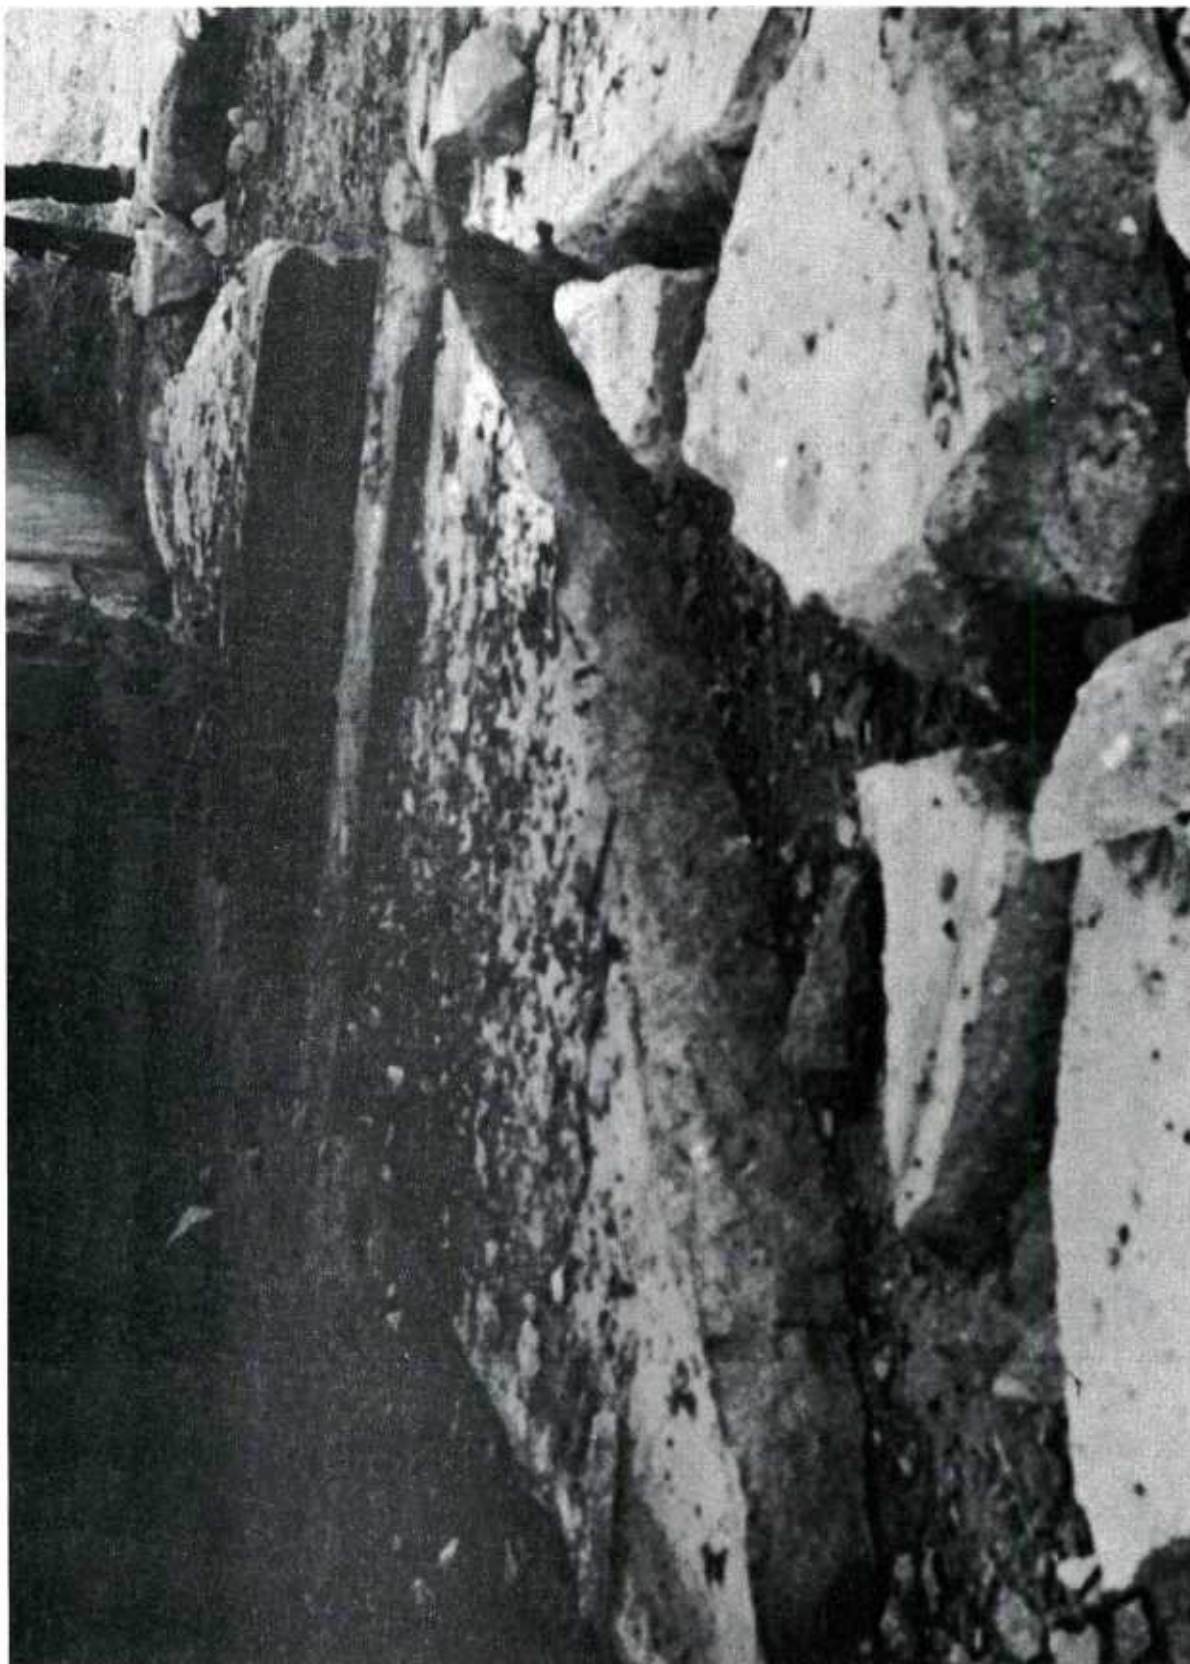
Figure 12. Test Results - Test No. 6, 5.4 Kg TNT Charge
Positioned Inside Magazine 4 Metres from Headwall

Test No.	Charge Wgt.	Charge Position	Remarks
4	5.4 Kg (12 lb)	4 m (13 ft) from headwall	The headwall separated from the sidewall and exhibited several large cracks. The headwall was still standing and held together by rebar. See Figure 10. The right door recovered 24 metres from the center of the headwall. The left door recovered 49 metres from the center of the headwall on the left side.
5	5.4 Kg (12 lb)	4 m (13 ft) from headwall	The headwall failed and separated into several large pieces, however, the headwall held in place by rebar. See Figure 11. The left door, almost intact, recovered 40 metres from the center of the headwall on the left side. The right door recovered in one piece 56 metres on the right side.
6	5.4 Kg (12 lb)	4 m (13 ft) from rear wall	The headwall failed completely, separated from the sidewall, and fractured into several large pieces. The left door recovered 31 metres to the side and 15 metres to the rear of the headwall. The right door recovered 27 metres to the side and 1.8 metres to the rear of the headwall. See Figure 12.

The complete headwall failures observed in Tests 6 and 8, where the 5.4 Kg charge was positioned 4 metres from the rearwall, were different in terms of structural response from the results of Tests 3, 4, and 5. However, these differences had little or no effect in defining hazardous distances. When the headwalls failed in Tests 6 and 8, they fractured into large pieces that were recovered in front of the blast shield. (See Figures 12 and 15.) The real hazards in the 5.4 Kg test series were the doors that were thrown clear of the area between the headwall and the blast shield after bouncing off the blast shield.
